# Retrofitting to Alleviate Effects of Corrosion in Cross Girders Under Inner Rail of Curved Railway Bridges

**Abstract:** The main railway line which spans from Colombo Fort to Badulla, is one of the nine railway lines of Sri Lanka Railways (SLR). The track alignment of the upcountry section (Rambukkana to Badulla) of the main line was defined about 150 years ago and it has a number of bends with sharp curves. Curved railway bridges are the bridges having railway bends on the bridge to bring gradual change of track direction. When considering with the total number of curved railway bridges, around 75% of curved bridges are located in the upcountry section of the main line. Corrosion of the cross girders beneath the inner rail of a railway bend is the most common problem encountered in curved bridges in the main line. In this study, the reason for corrosion of cross girders of curved railway bridges was investigated through a detailed study of two corroded curved truss bridges in the upcountry section of the main railway line. Current strength of bridge materials and its microstructure were investigated with in-situ hardness measurements and microscopic examination, respectively.

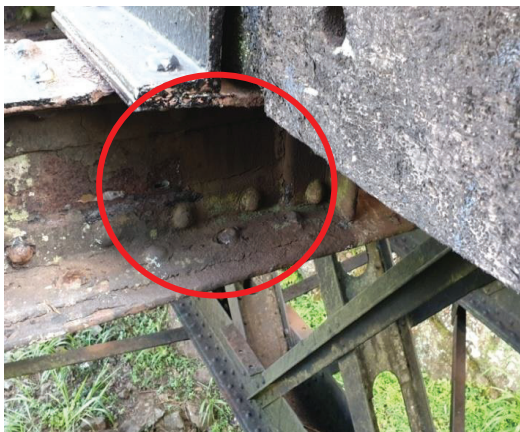
**Figure 1 - Two views of corrosion in a curved bridge**

In upcountry curved railway bridges, corrosion of the cross girder section beneath the inner rail has been observed. Such corrosion is critical in some of the upcountry railway bridges. Ignoring such a corrosion issue would aggravate local buckling phenomena of the cross girders violating the safety of bridges. Figure 1 shows two views of corrosion of curved railway bridges.

Signs of corrosion were found mainly in web sections of the cross girders under the inner rail. Mostly affected cross girders are 5, 6, 9, 13, 14, 15 (from Haputhale to Diyathalawa direction). Also, corrosion appears in pocket plates as shown in Figure 1 (b).

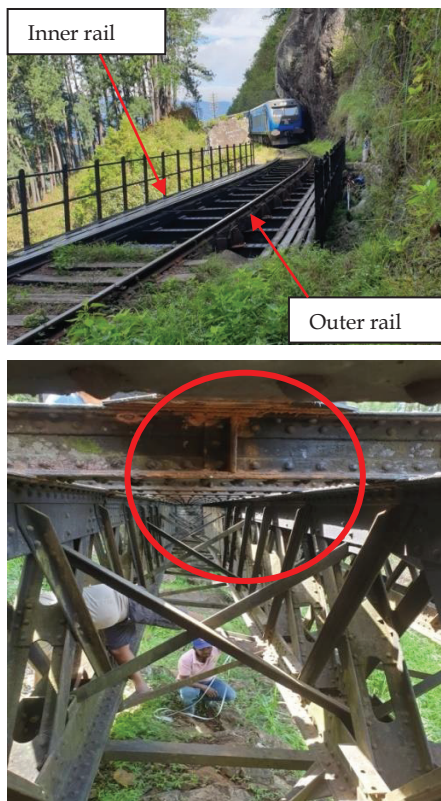
Figure 3 - Two views of the case study bridge I

The bridge has three lattice trusses with equal distances and a total of seventeen cross girders. Cross girders are supported on the top chords of three lattice trusses. Timber planks have been provided between railway line and cross girders in longitudinal direction to transfer the train loads smoothly to the bridge. Overall length of bridge is 60 ft and the clear span is 20 ft. The bridge is made out of wrought iron and substructure of the bridge consists of two stone masonry abutments, having pinned end support and free end support. Two views of the bridge are shown in Figure 3.
