# Mineralogical Evolution and Geo-mechanical Characterization of Weathering Profiles Along the Central Expressway (CEP 3), Sri Lanka

**Abstract :** This research investigates the mineralogical and geo-mechanical factors influencing slope stability along Section 3 of the Central Expressway Project (CEP 3), Sri Lanka. Through a combination of borehole logging, petrographic analysis, and X-ray diffraction (XRD), a comprehensive weathering profile was established. Results delineate a transition from stable, fresh metamorphic gneissic rocks to highly unstable residual soils (SM and ML types). Petrographic data reveal the progressive alteration of primary minerals, specifically Feldspar, Biotite, and Hornblende, into secondary Clay phases. XRD analysis identified the presence of Smectite and Kaolinite, with the former presenting significant risks for moisture-induced volume changes and rotational slides in high-cut sections. The study concludes that the thickness and stability of the residual mantle are directly governed by the modal mineralogy of the metamorphic parent rock, providing a critical framework for geotechnical risk mitigation in hilly terrains.

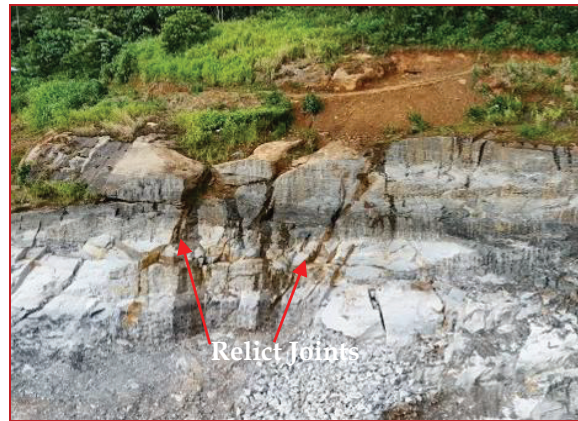
Figure 3 - Highly Jointed Meta-sedimentary Rocks at CEP 3 Cutting Location

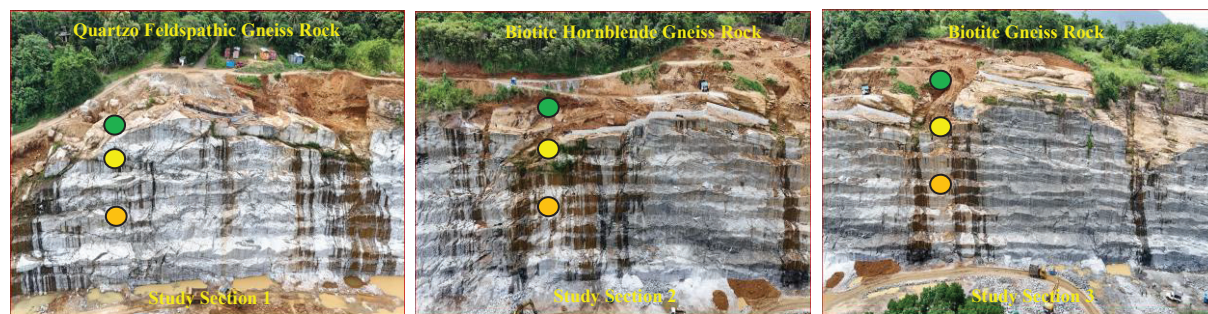
● Residual soil ● Highly/Moderately Weathered rock ● Slightly Weathered/Fresh rock

Figure 7 - Sample Collected Points at Study Sections of Location (Ch: 9+500 km - Ch: 10+100 km)

Undisturbed residual soil samples were retrieved from depths of 0-2.5m. Complementary rock samples were obtained from boreholes and exposed cut-slope sections to capture a complete weathering profile (Figure 7).
