## GEOSPATIAL ASSESSMENT OF SHORELINE DYNAMICS FOR SUSTAINABLE POLICY SHIFTS: EVIDENCE FROM RAPIDLY DEVELOPING COASTAL ZONES

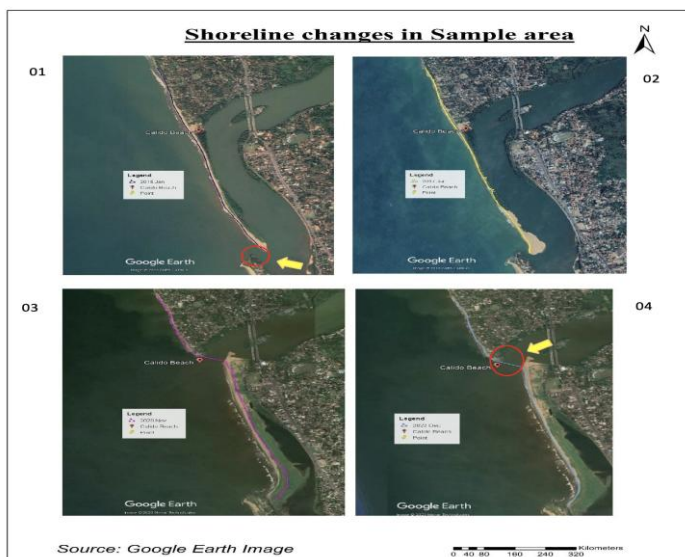
*Figure 5 : Shoreline Changes in Sample Area*

Figure 5 clearly illustrates the directional movement of shoreline changes over time. These images also demonstrate that the position of the river mouth. The river mouth was altered following the cutting of the sand bar during the 2017 flood event. The first image depicts the original river mouth position. The fourth image, marked with a red circle, shows the current river mouth location. The removal of the sand bar can be seen in the last two images, and the yellow line on

the sand bar in 2017 has been erased in the 2020 map. Within the time period, it is clear that the river mouth has changed.

However, driven by short-sighted political decision-making and other human and natural phenomena, it has generated a range of adverse consequences. The first is the displacement of the Kalu River mouth, as illustrated in

Figure 5, where the changed river mouth position is indicated by a red circle. Before the cutting of the sandbar, the river mouth was located adjacent to the Avani Kalutara Resort. However, its current position has been substantially altered, and it has direct implications for the nearest island.

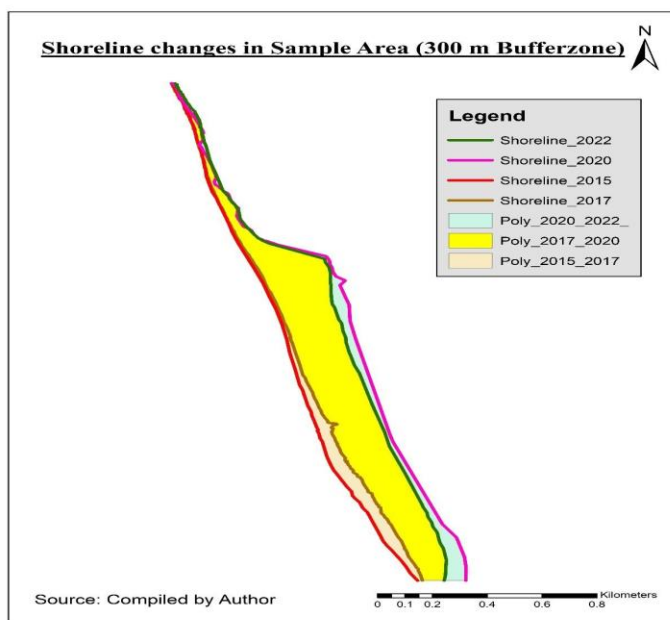
*Figure 6 :Shoreline changes in the Sample area (300m Buffer-Zone)*

Shoreline change analysis enables the calculation of coastal geomorphological change through geometrical calculation. As a preliminary step, the sample area and shoreline polygons were demarcated. Figure 6 presents the resulting shoreline polygons within the 300-metre buffer zone of the sample area as a visual representation of the Calido coastline.

Figure 6 presents shoreline changes within the sample area across the defined time intervals, as represented by 300-metre polygons. In 2015, the red colour line indicates the shoreline with a large area to the ocean. It has changed in 2017. When it comes to 2020, the map indicates drastic land erosion morphologically. In 2022, the erosion has recovered to some extent, and the green line shows the land accretion compared to 2017-2020. Based on these polygonal extents, coastal morphological changes, specifically erosion and accretion, were calculated. Table 2 shows the aggregated result of the polygon area in sq.m.
