# Vacuum Failure Experiments on a Liquid Hydrogen Tank

RESEARCH

Goff, R., Wray, G. and Coldrick, S. (2026) 'Vacuum Failure Experiments on a Liquid Hydrogen Tank', *Hydrogen Safety*, 3(1), pp. 97–114. Available at: <https://doi.org/10.58895/hysafe.46>

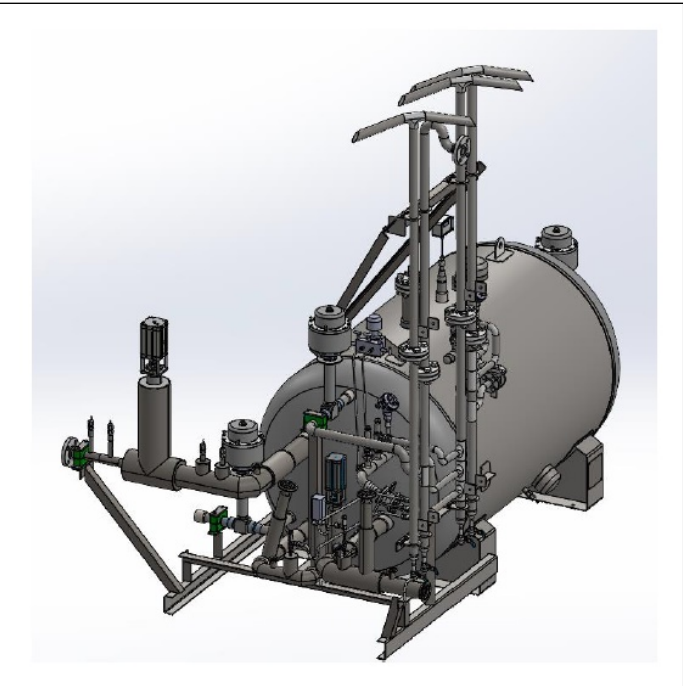
**Figure 4** An overall view of the tank design.

[Figure 3](#) shows the P&ID created for the tank, and [Figure 4](#) shows the design drawing of the tank. The measurements of the tank are shown in [Figure 5](#). The capacity of the inner tank was  $1.5 \text{ m}^3$ . Both inner and outer tanks had ASME flanged and dished ends, with the surface areas of the inner and outer tanks being  $6.69$  and  $9.93 \text{ m}^2$ , respectively. Both inner and outer tanks were specified for a maximum operating pressure of 10 barg. The inner tank was also designed to take a reverse pressure of 10 barg. Normally, the outer tank would only be specified for 1 barg, but a higher pressure rating was needed in case it were to be pressurised during the experiments.

The cylindrical section of the inner tank was 6 mm thick and had three equally spaced  $50 \times 50 \times 5 \text{ mm}$  angle stiffening rings. The dished ends were pressed from a 6 mm plate. As a comparison, the cylinder only needs to be 4 mm thick for 10 barg internal pressure; the extra thickness and stiffening rings are to resist the reverse pressure. The cylindrical section of the outer tank was 5 mm thick due to the 10 barg maximum operating pressure; however, a standard tank built for 1 barg would only be 4 mm thick. The dished ends of the inner and outer tanks were 6 mm thick.

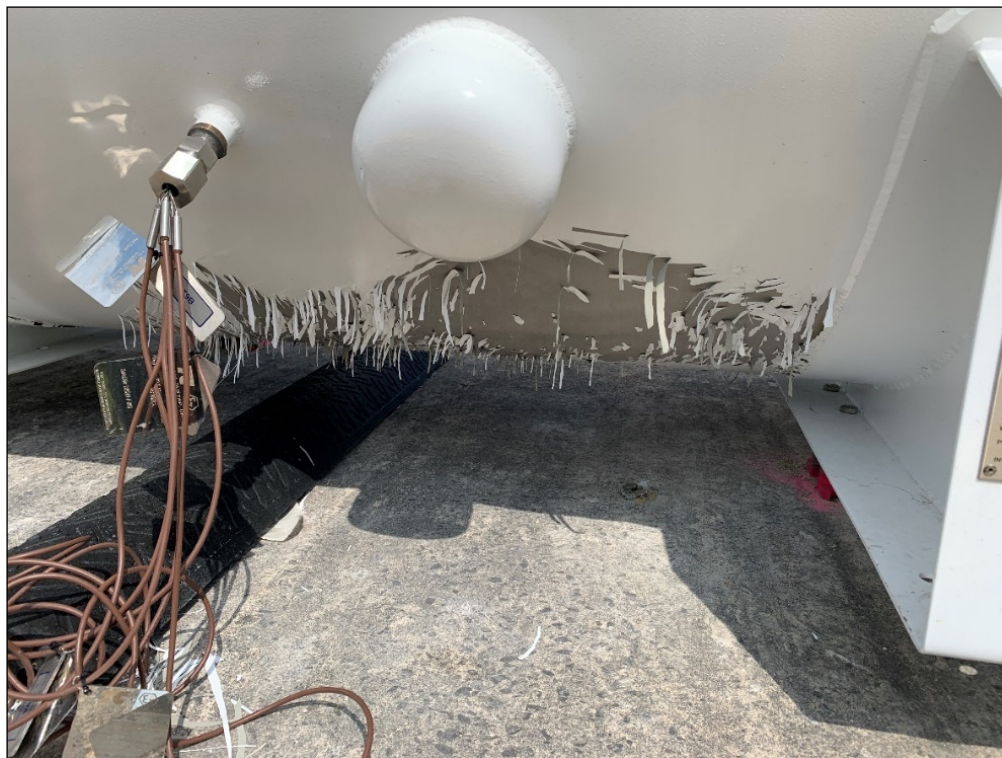
It was found after the test that the paint had peeled off the underside at the  $H_2$  connection end and along the cylindrical section. This can be seen in [Figure 10](#). A camera recording a video of the experiments lasted for three hours, and no indication of damage to the paint was seen in it. A thermal imaging camera recorded data for five minutes after the breaking of the vacuum; no cooling was detected to the underside of the tank in that time. Thermocouples on the outer tank at high and low levels did not detect any deviation from ambient temperature while logging (around 30 minutes).

**Figure 10** The paint peeling from the underside of the tank.

The likely explanation is that cryogenic liquids pooled at the bottom of the tank while the tank was warming up, with the solid  $N_2$  that condensed on the inner tank wall turning to liquid. The datasheet for the paint used does not specify a minimum service temperature (only a maximum is specified) but gives a minimum curing temperature of  $-10^\circ\text{C}$ . It can be assumed that the temperature that caused the damage was lower than the minimum curing temperature. The paint in this case was aesthetic, as the outer tank was made of stainless steel, but it could be a problem for a larger tank where the outer tank may be made of mild steel. This paint loss is indicative that cold temperatures could be occurring at the base of the tank following vacuum failure.

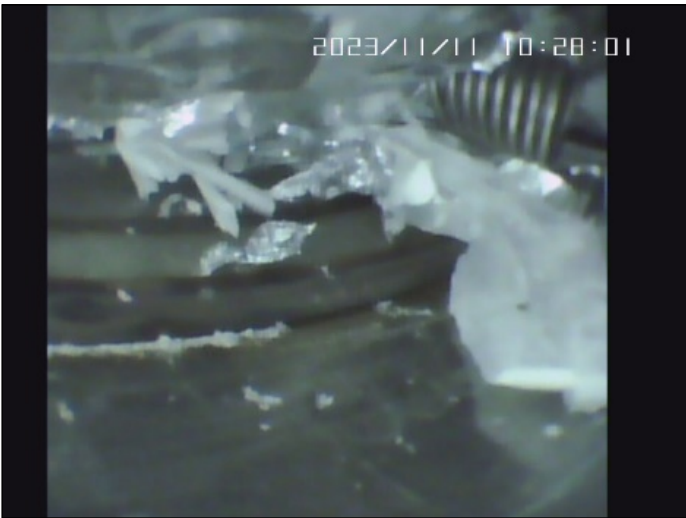
**Figure 14** Torn MLI accumulated around a coil in the outer tank. Abbreviation: MLI, multi-layer insulation.

After the observation of glass fibre tissue in the valve to the vacuum pump, a borescope was used to observe damage to the MLI in the outer tank. Access was achieved by cutting through some of the penetrations into the outer tank. Some examples of the damage are shown in [Figures 14](#) and [15](#). [Figure 16](#) has a schematic showing where damage occurred on the MLI.

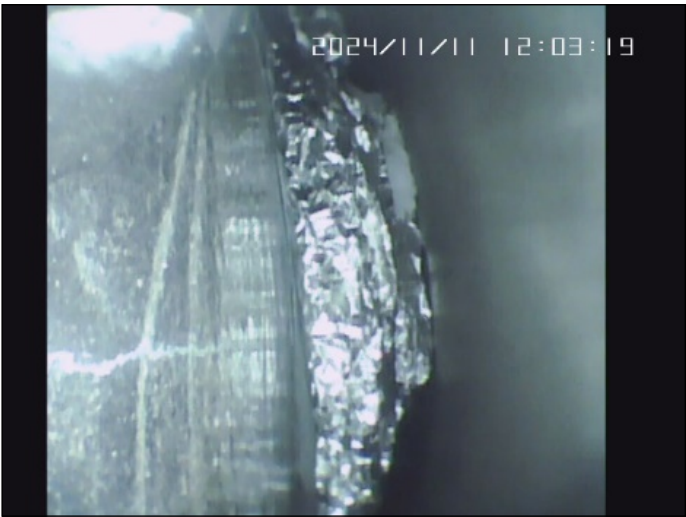
**Figure 15** Layer(s) of MLI peeled back along the cylindrical section of the tank. Abbreviation: MLI, multi-layer insulation.

Along the cylindrical section, damage was observed at the joins in the blankets halfway along and at overlaps with domed ends. Some layers of MLI had peeled back. Damage was also observed near penetrations.
