Acta Technologica Agriculturae 4  
Nitra, Slovaca Universitas Agriculturae Nitriae, 2024, pp. 234–241

## INSPECTION OF RUBBER PARTS OF MILKING EQUIPMENT BY NON-DESTRUCTIVE TESTING METHOD

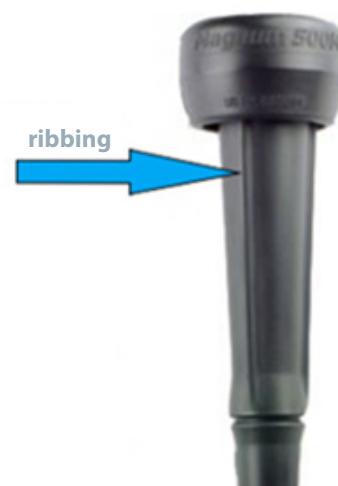
**Fig. 1** Ribbed teat cup liner

The teat cup liner Magnum MX400 had a mark on the head and on the short milk tube so that it was correctly fitted after assembly in the nipple case. The first roughness

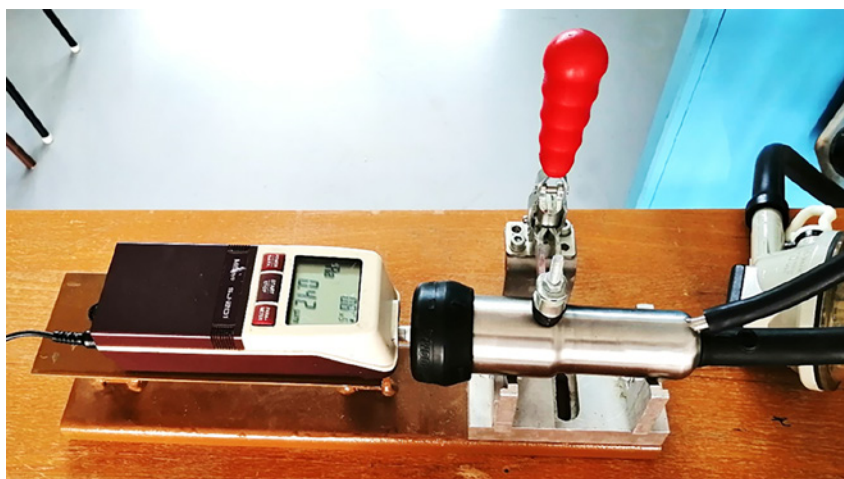
The Mitutoyo Sj 210 roughness meter was used to measure roughness. The technical data of the device: velocity: 0.25 mm·s<sup>-1</sup>; return: 0.8 mm·s<sup>-1</sup>; used probe for soft materials 4 mN; tip radius 10 µm; used extension 50 mm; roughness parameters  $R_a$ ,  $R_z$  ( $R_a$  – the mean arithmetic deviation of the profile in the range of the basic length;  $R_z$  – the arithmetic average of the largest profile heights); evaluated length ( $L$ ) – 0.8 mm; the number of sampling lengths  $\times 5$ ; power supply via mains adapter (manufacturer: Mitutoyo, Kawasaki, Kanagawa, Japan). Solidworks version 2015 (Dassault Systems SolidWorks Corporation, Waltham, MA, USA) was used to construct the 3D model. The Excel spreadsheet program from Microsoft Office Excel (Microsoft, Redmond, USA) was used to collect data from individual measuring devices. The obtained data were evaluated using ANNOVA, Statistica CZ 7 (TIBCO, Palo Alto, USA). The measuring bench for determining the roughness of the teat cup liner is shown in Fig. 3.

**Fig. 3** Measuring bench for determining the roughness of the teat cup liner
