# SEISMIC DAMAGE ASSESSMENT OF DEFICIENT REINFORCED CONCRETE FRAME STRUCTURES

## Abstract

## 2 Experimental program

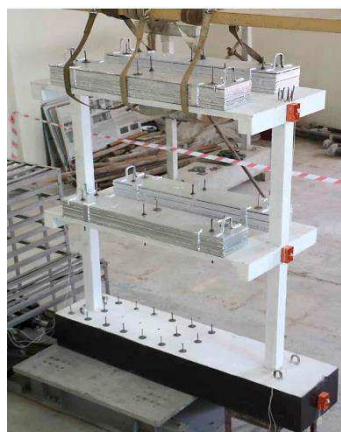
Fig. 3: Extra weights in the form steel plates for seismic mass modeling.

It is also worth mentioning that, due to reduced scaling, the test model will be subjected by reduced force due to mass simulation. In order to simulate the seismic mass during the dynamic testing, extra seismic mass 1200 kg in the form of steel weights were provided on each story, as shown in Fig. 3. Table 1 also reports the concrete mix proportion based on the ACI mix proportion procedure, for the code specified compressive strength of 21 MPa (3000 psi) and reduced concrete strength of 14 MPa (2000 psi) using reduced size 9.53 mm (0.375 in) coarse aggregate.

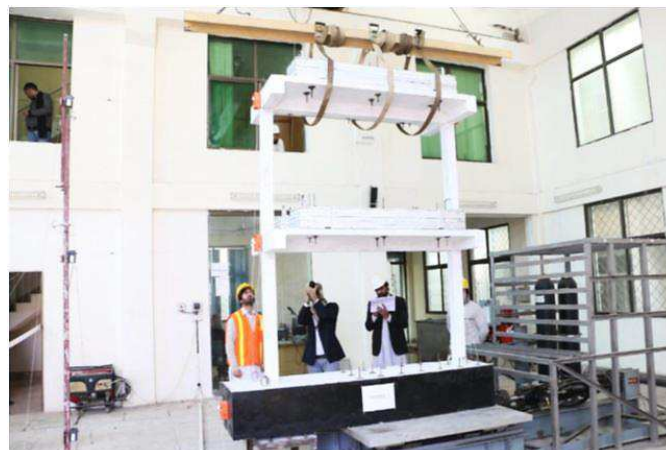
Fig. 4: 1/3rd reduced RC frame model setup.

Fig. 4 shows the experimental specimen testing setup, whereas, Table 2 and Fig. 5 shows the external instrumentation layout detail. In order to obtain acceleration responses, the test model was installed with one accelerometer on the base level and two pairs of accelerometers on the first and roof story level, one on the front and second on the back side. Similarly, to measure the displacement responses, three linear variable displacement transducer LVDT were installed on a steel reference frame, and were in line with the base, first and roof story level.
