# PANELS OF COLD-FORMED STEEL PROFILES: POSSIBILITY OF THEIR USE TO REPAIR WAR-DAMAGED LARGE-PANEL BUILDINGS

## Abstract

*In the paper, we present the results of an analysis of data samples of 282 damaged buildings; the samples include the age of the building, the type of vertical bearing structures, the type of construction of the external walls, the method of the insulation of the walls, the number of floors, the buildings' functions, and the extent of the damage. The primary objective of the analysis was to evaluate the possibility of using panels of cold-formed thin-walled steel profiles to repair the damaged structures. The results of a study of typical projects of large panel buildings that were constructed in Ukraine and an analysis of the practical experience of repairing these types of buildings after blast actions can also be found. The research tasks are defined for implementing this technology in the process of repairing large panel buildings.*

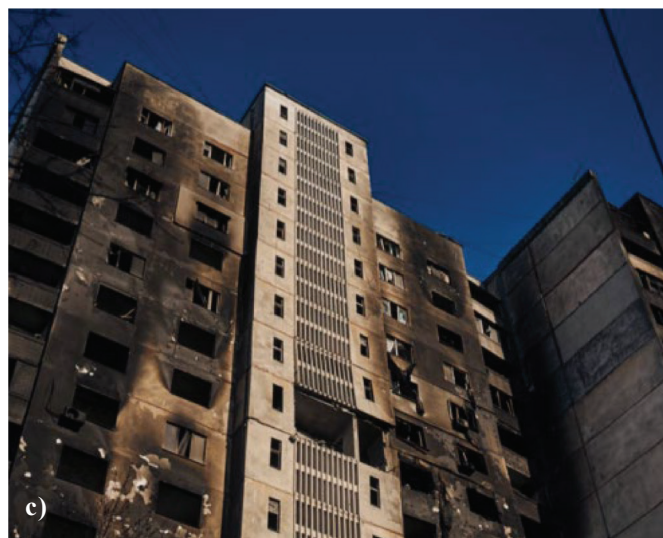
**Fig. 1** Examples of partially destroyed large-panel buildings

You can see photographs of the repair process of buildings, including large panel buildings (Fig. 5). The (Fig. 1a) photo shows the renovation process of a building using the installation of new lightweight self-supporting lightweight concrete walls instead of large panels. The advantages of this method are not evident. This method is not industrial, and it is impossible to repair all of the damaged infrastructure, which includes thousands of multi-apartment buildings. This is why the possibility of developing industrial (or prefabricated) solutions, which enable maximum work to be done on the ground and the erection of panels on any floor using simple lifting mechanisms, is unquestionably realistic.

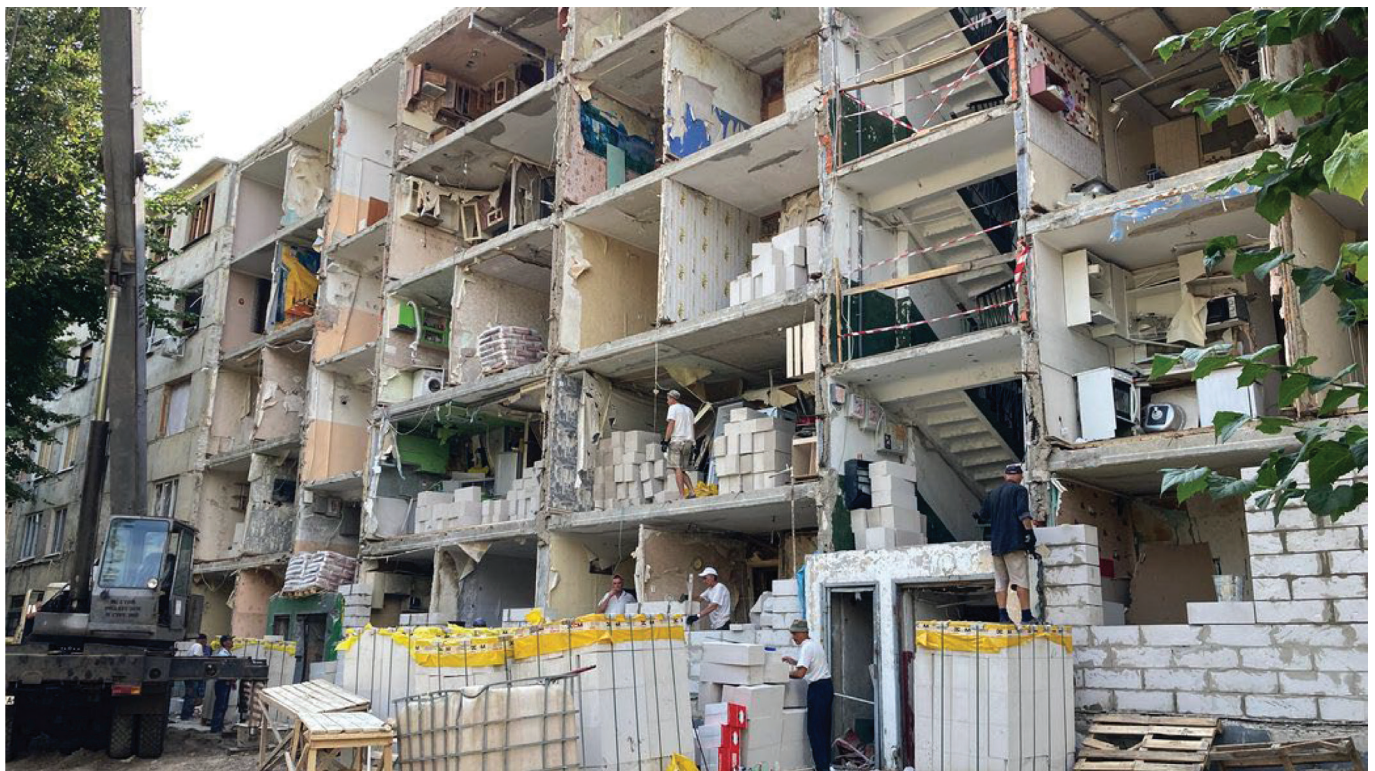
**Fig. 5** The repair process of a large-panel building (sources: Information at <https://cdn4.suspilne.media/images/resize/1040x1.78/680874f014cfdd08.jpg>)
