# NON-DESTRUCTIVE TESTING OF A HISTORICAL VAULT USING GROUND PENETRATING RADAR METHOD

## Abstract

The article presents the results of research conducted in the Main Building of the Gdańsk University of Technology, which was destroyed in the World War II, reconstructed and included in the Register of Historic Buildings several decades ago. The study was carried out on the ceiling above the second floor, in the central part of the building at the 3rd level, in the hall in front of the Main Hall. The primary objective was to identify the geometry of the vault and assess the feasibility of detecting its internal structure using the non-destructive ground penetrating radar (GPR) method. A GPR system with a 2 GHz antenna was used for the study. Selected echograms (B-scans) in both scanning directions and tomographic maps at different depths were presented. The results indicate the presence of steel load-bearing beams in both directions, as well as a steel grid in the central part of the ceiling, while also mapping the boundaries of the vaulted structure. This research is particularly important due to the limited availability of technical documentation for the analysed area. The finding

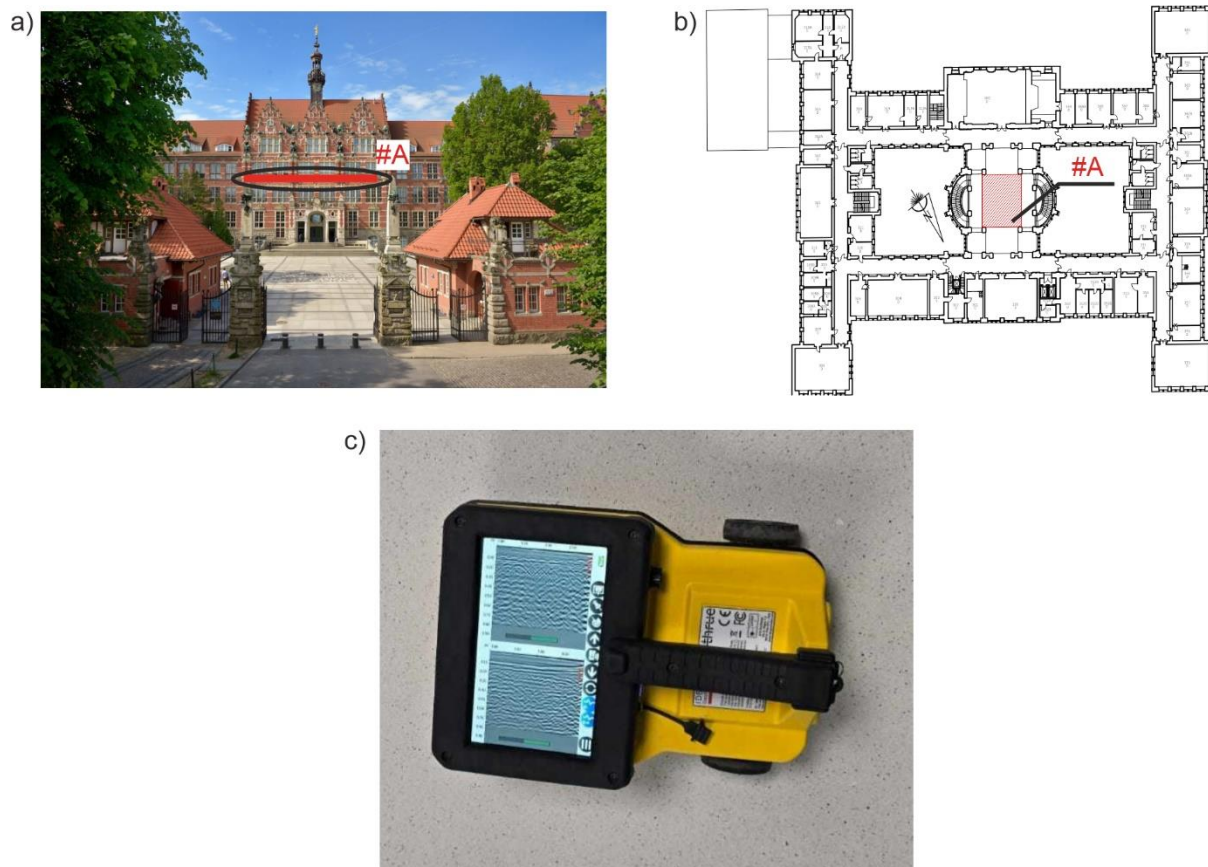
Fig. 2: Measurement area #A: a) location of the ceiling, b) marking on the 3. floor plan, c) ground penetrating radar used in measurements.

The investigation was carried out in the Main Building of Gdańsk University of Technology, on the ceiling above the 2nd floor, i.e., at level 3<sup>rd</sup>. The place inspected is presented in Figures 2a and 2b. For the GPR survey, a rectangle measuring 1200 cm x 1020 cm was selected in the central part of the 3<sup>rd</sup> level. This research area (#A) was chosen to allow for unrestricted movement of the measuring equipment along predefined routes. To ensure comprehensive coverage, 52 longitudinal profiles (L1-L52) and 61 transverse profiles (H53-H113) were marked on the inspected area. Both longitudinal and transverse profiles were placed at 20 cm intervals. The sections of the floor subjected to the survey, together with the measurement routes described, are illustrated in Figure 3. The measurements were conducted using an IDS C-THRUE georadar system, which is equipped with four antennas, each operating at a central frequency of 2 GHz. This GPR is designed to provide high-resolution imaging, enabling precise detection of subsurface structures and anomalies. It has an effective penetration depth of several tens of centimeters, making it well-suited for analyzing subsurface features with high accuracy.
