Reopening of the Footbridge in Bratislava Exposed to Fire

Journal of the Faculty of Civil Engineering | University of Žilina

Bridge failures due to fire are very rare, and they are mostly caused by traffic accidents involving a tanker truck under or on the bridge. The article deals with a fire of the high voltage electric line attached to the main girders of the approach footbridge to the Harbour Bridge over the Danube that damaged some parts of the structure. Detailed diagnostic survey confirmed that fire adversely affected the mechanical properties of the concrete in the girder's webs and in the top reinforced concrete slab of the last span. Because their effect on the structural behaviour of the girders was very difficult to assess, the re-opening of the footbridge was conditioned by the favourable results of the load test. Due to restricted access to the cars on the footbridge, the structure was loaded with a set of water tanks that were filled with water pumped from the Danube River. Comparison of the deformations obtained on a damaged girder and a reference girder confirmed by fire caused defects when vertical displacement was 17.5% greater than in the reference girder; how

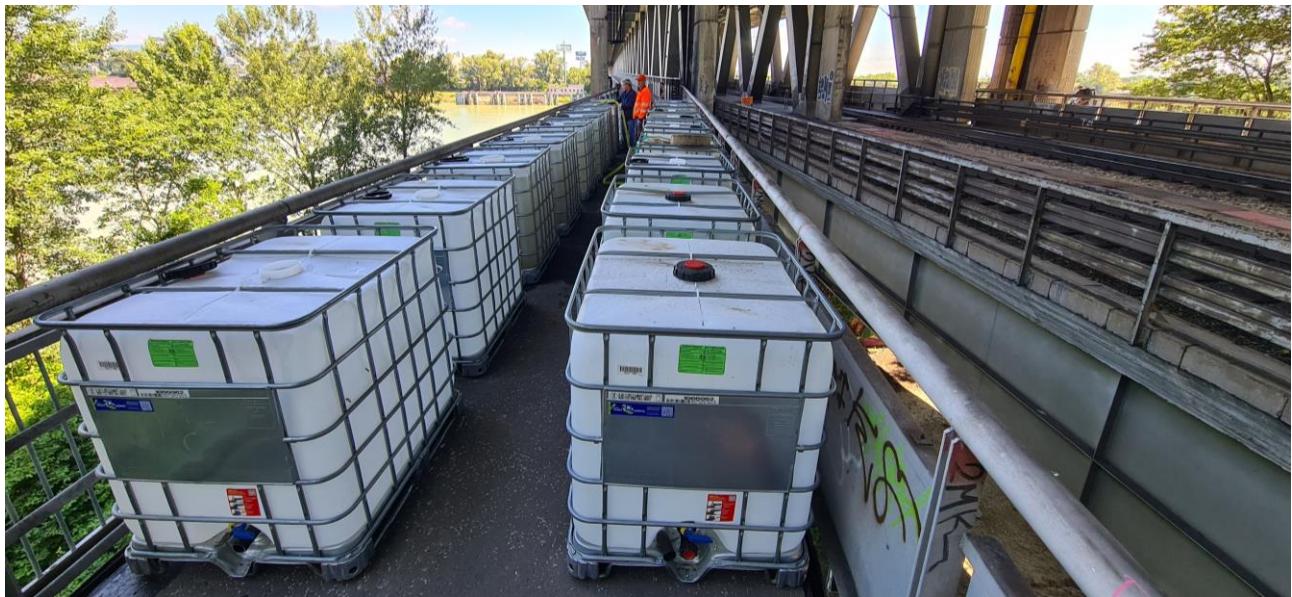
The load test proposed for the footbridge had one major obstacle. The footbridge is not accessible for the other traffic except for pedestrians and cyclists. Therefore, loaded tracks could not be used as testing load. Fortunately, the damaged span is close to the river Danube and water from the river can be pumped to the plastic tanks and used as a testing load, see Figure 5.

Figure 5: Plastic tanks used as testing load

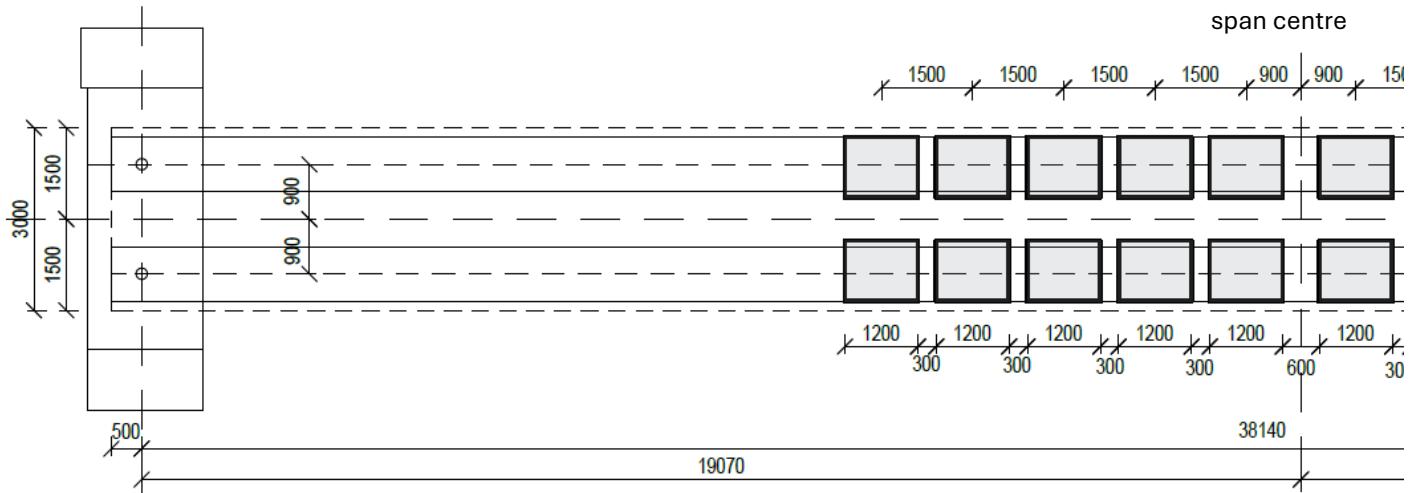
Arrangement of the water tanks in the damaged span N1 is shown in Figure 6. The same arrangement was used in the neighbouring reference span N2. For the calculation of the bending moments and deflections due to the testing load, a FEM model in the program SCIA Engineer was created, see Figure 7. The bending moment in the centre of the span due to

Figure 6: Arrangement of the tanks on the damaged span – girder N1

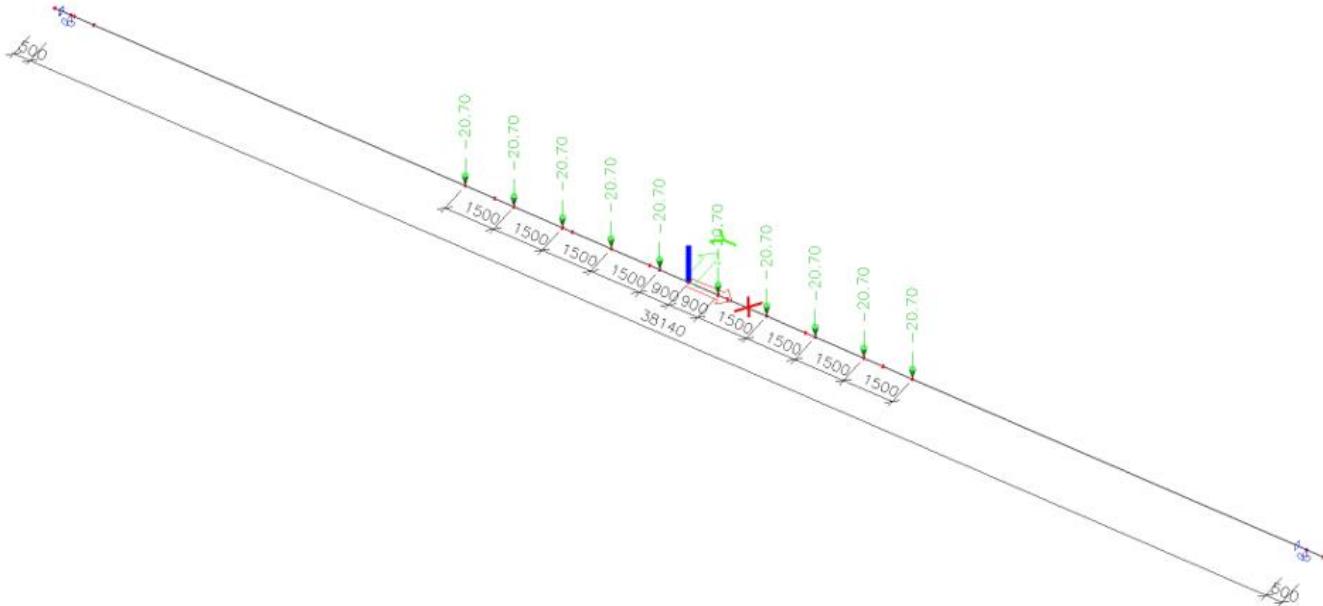
testing load was 1570 kN.m and the expected deflection was -5.8 mm. A ratio of the load effectiveness of $1.57/2.046 = 0.767$ (76.7%) was achieved. The testing load was equivalent to the pedestrian load of $0.767 \cdot 3.76 = 2.88 \text{ kN/m}^2 > 2.50 \text{ kN/m}^2$. Both tested girders were mostly in the shadow during the load test; therefore, changes in deflection due to thermal load were minimal. After unloading, the deflection changed to a camber of +0.5 mm in beam N1 and +0.4 mm in beam N2 due to temperature changes during the load test.

Figure 7: FEM model of the footbridge structure - girder N1
