# Monitoring of Crack Flank Movement in a Steel Orthotropic Deck

Rudolf ÁROCH<sup>1,\*</sup>, Tomáš KLAS<sup>1</sup>, Ján BRODNIANSKY<sup>1</sup>

<sup>1</sup> Department of Steel and Timber Structures, Faculty of Civil Engineering, Slovak University of Technology, Radlinského 11, Bratislava, Slovakia.

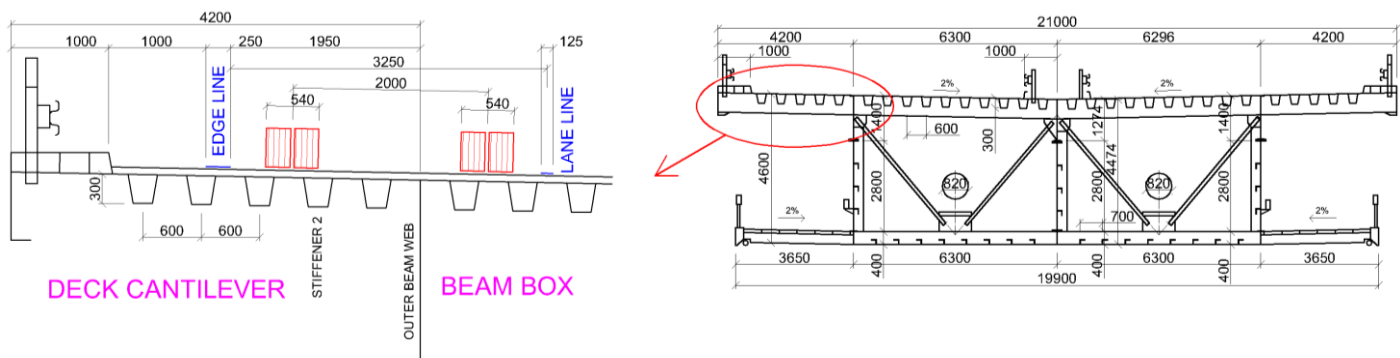
**Figure 1:** Detail of the bridge cross-section and position of vehicles in the outer traffic lane

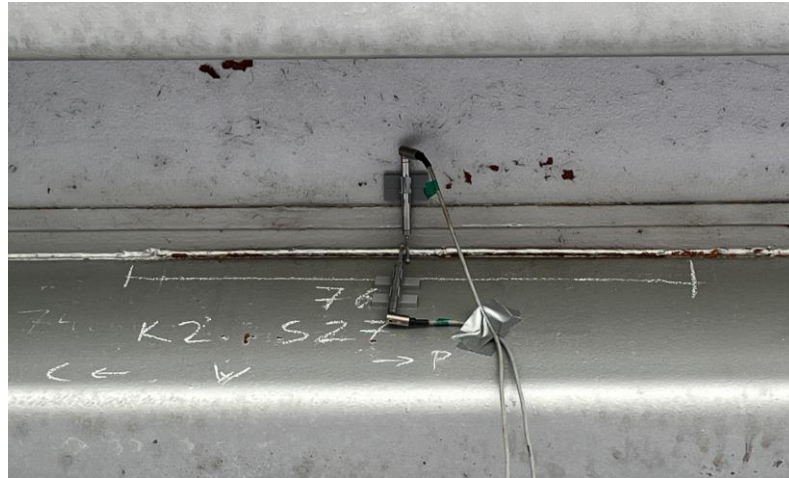
- Crack location: Vienna walkway, Section 27, Stiffener 2, Vienna side, approx. quarter-span of stiffener.
- Crack length: ~76 cm.
- Sensors: Vertical and horizontal LVDTs (Figure 5).

**Figure 5:** LVDT placement at Section 27 - vertical and horizontal

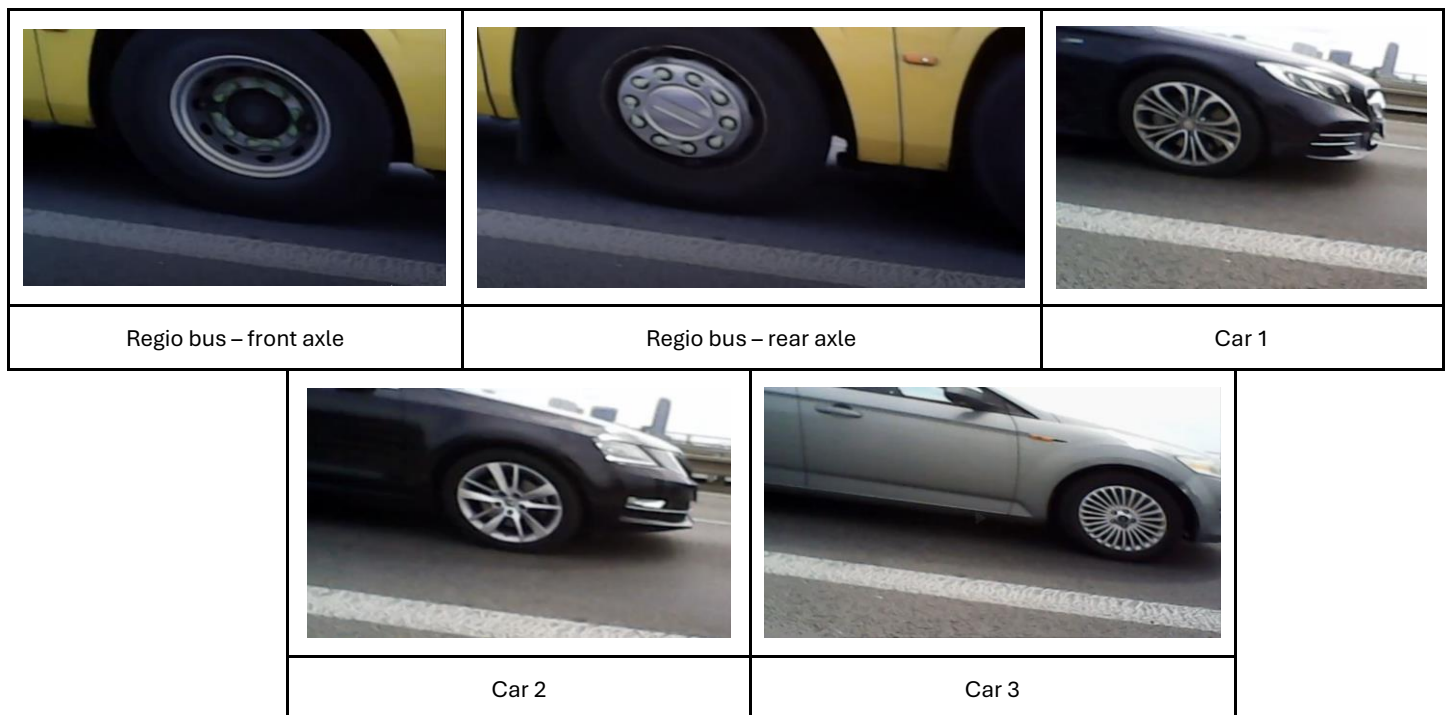
Vehicle positions during the measurement were determined from video stills (Figure 7). The edge line width of 25 cm was used to estimate the precise wheel position relative to the underlying deck stiffeners.

**Figure 7:** Vehicle positions relative to the edge line – Case 1**Traffic Scenario 2:** Bus SOR in the outer lane

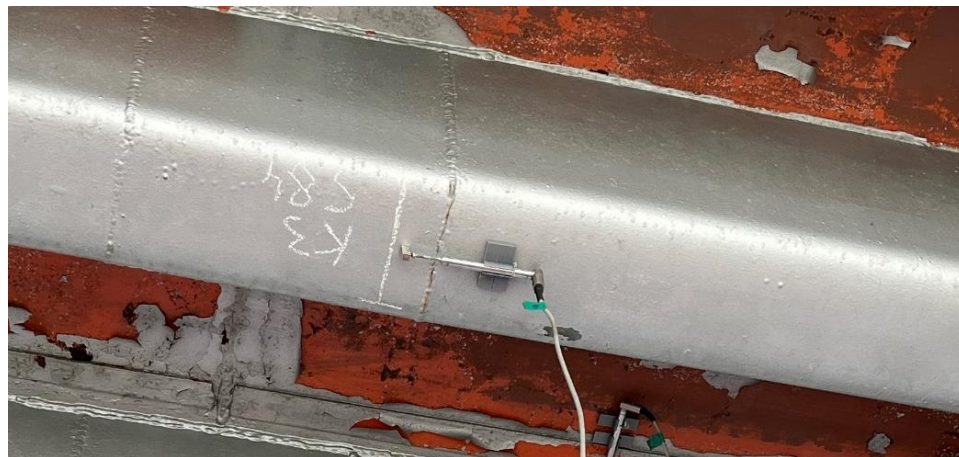
- Crack location: Budapest walkway, Section 84, Stiffener 3, stiffener bottom flange at mid-span.
- Crack length: ~20 cm.
- Sensor: Horizontal LVDT (Figure 5).

**Figure 10:** LVDT placement at Section 84 - horizontal
