# THE IMPACT OF VRANCEA MARCH 4, 1977 EARTHQUAKE ON THE BUILT ENVIRONMENT OF CRAIOVA

**Abstract:** Considering the adverse effects of 1977 Vrancea earthquake in Craiova, in addition to the old single-family residential buildings that suffered significant damage, newly built collective housing blocks constructed between 1960 and 1975 also showed major structural issues. A total of 69 buildings comprising 121 sections were identified. Fortunately, no collective residential buildings collapsed. Craiova had the highest number of large residential buildings damaged after Bucharest. Craiova was not considered a seismic zone according to the 1963 seismic zoning code, and therefore the structural requirements and seismic design regulations were not incorporated into the design of its buildings. This changed in 1978 due to the new seismic design code enforced at that time, when the structural systems made of masonry walls were replaced by large prefabricated panels in residential buildings with a height regime of ground floor plus four stories (GF+4S). Unfortunately, for the buildings damaged by the March 4, 1977 earthquake, only partial repair and retrofitting works were carried out.

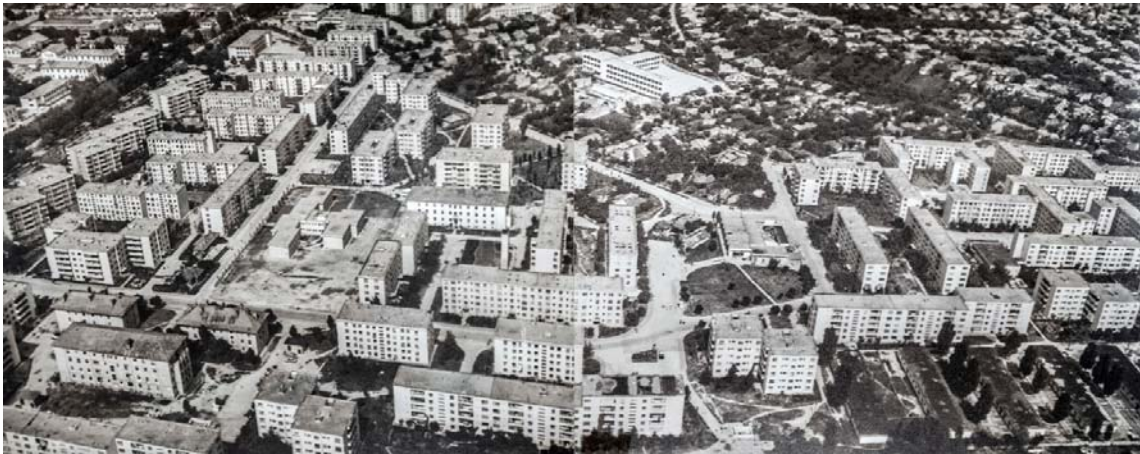
**Fig.3.6** - Buildings in the Valea Roşie district – 1975

The buildings were identified based on the elements present on the facade in the Valea Roşie district, totalling 31 buildings with the same characteristics.

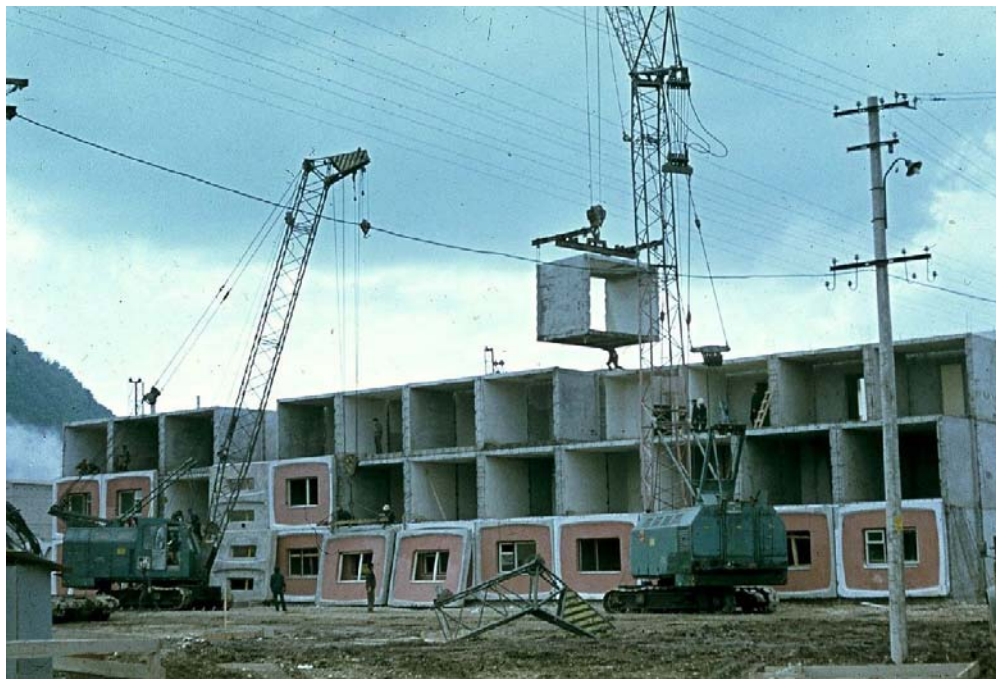
Fig. 3.15 - “Spatial Boxes” produced at the Prefabricated Components Factory in Braşov

The study [16] mentions a building in Craiova that experienced a particularly unusual failure. In structures with “spatial box” systems, the columns between the prefabricated concrete boxes were reinforced with post-tensioning. This reinforcement was anchored at the foundation level into the bands of the slab above the basement. In one such building under construction, a failure of the anchorage was observed at the slab above the first floor.
