# POSSIBLE APPROACHES OF NUMERICAL MODELLING OF SEEPAGE ANOMALIES AND CUT-OFF WALL SOLUTIONS FOR EARTHFILL DAMS

Emília BEDNÁROVÁ <sup>1</sup>, Juraj ŠKVARKA <sup>1\*</sup>, Marián MINÁRIK <sup>2</sup>, Branislav VLČEK <sup>3</sup>

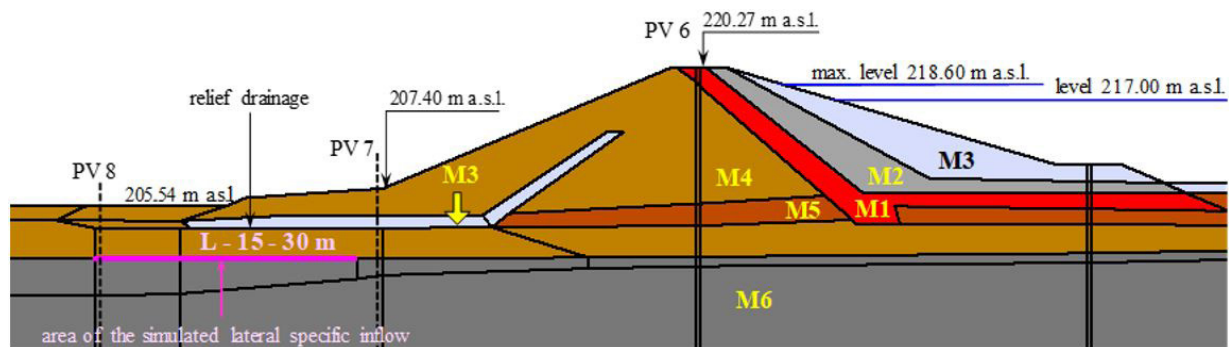
Fig. 7 Cross-section of the dam on the alluvial plain (PV6 – PV8)

Based on the results of a geological survey, hydraulic conductivity values were assigned to the structural elements of the dam's subsoil (Fig. 7). The adopted values represent averages of the ranges measured and are summarized in Table 1. The variability of the M2 and M3 materials was not considered, as their effect on the groundwater regime in the dam body and subsoil (profiles PV6, PV7, and PV8) is negligible.

Without simulating an additional inflow into the subsoil, the initial calculations showed that the groundwater levels calculated did not correspond to the in situ measurements in PV7 and PV8. In particular, the simulated values for PV8 were consistently lower than the in situ measurements. This confirmed the significant role of the relief drainage system, which effectively captures seepage through the PV6–PV8 profile but does not intercept water bypassing the dam along the left valley slope (Fig. 6).

Verification of the model was carried out using more than 20 variants for the PV6–PV8 profile. The results highlighted the sensitivity of the groundwater regime both to the hydraulic conductivity of the dam and foundation materials and to the parameters defining the lateral inflows from the left valley slope. The final configuration of the parameters input was adopted for subsequent parametric analyses. This verified model served as the basis for designing and optimizing remedial measures at the maximum operating reservoir level of 218.6 m a.s.l., with the objective of eliminating the anomalous seepage regime in the PV6–PV8 profile.

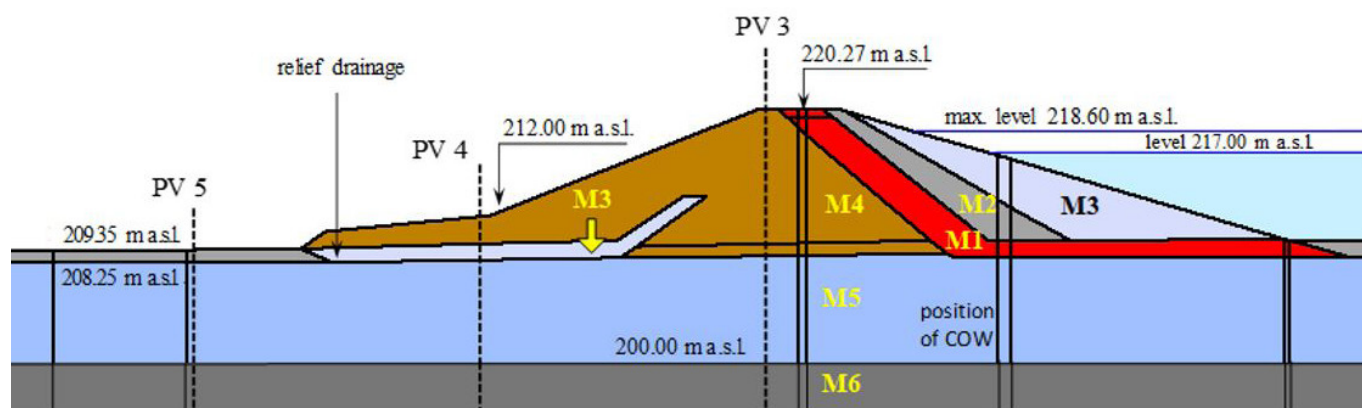
Fig. 8 Cross-section of the profile of the dam in the valley stream profile (PV3–PV5)

The cross-section of the PV3–PV5 profile is shown in Fig. 8. The hydraulic conductivity values of the dam body soil were derived from the verification process in the PV6–PV8 profile. The composition of the dam subsoil was determined based on a geological survey and a longitudinal survey along the relief drainage system (Fig. 3). According to these results, hydraulic conductivities were assigned to the individual subsoil layers, which were then used for the verification of the numerical model.

(M4 material – Tab.1). Both solutions provided satisfactory agreement with the field data. The adopted composition of the PV3–PV5 profile (M5:  $k_f = 4.0 \cdot 10^{-5} \text{ m} \cdot \text{s}^{-1}$ ) corresponds to a specific seepage of  $2.03 \cdot 10^{-5} \text{ m}^2 \cdot \text{s}^{-1}$  through the dam subsoil. Approximately 20% of this seepage is activated as lateral inflow, i.e.,  $1.05 \cdot 10^{-7} \text{ m} \cdot \text{s}^{-1}$ , which is equivalent to  $4.05 \cdot 10^{-6} \text{ m}^2 \cdot \text{s}^{-1}$  over a length of 27 m in the PV6–PV8 profile.

When evaluating the effect of the cut-off wall in the PV3–PV5 profile, the potential effect of the slope water was not considered, although it may have contributed to the groundwater levels observed in PV5. However, this simplification does not significantly affect the explanation of the anomalous regime in the PV6–PV8 profile or the design of remedial measures. The verified numerical model was therefore used in a parametric study at the maximum operating level of 218.6 m a.s.l. (Fig. 9), which provided the basis for optimizing measures aimed at eliminating anomalous groundwater conditions in the PV6–PV8 profile.

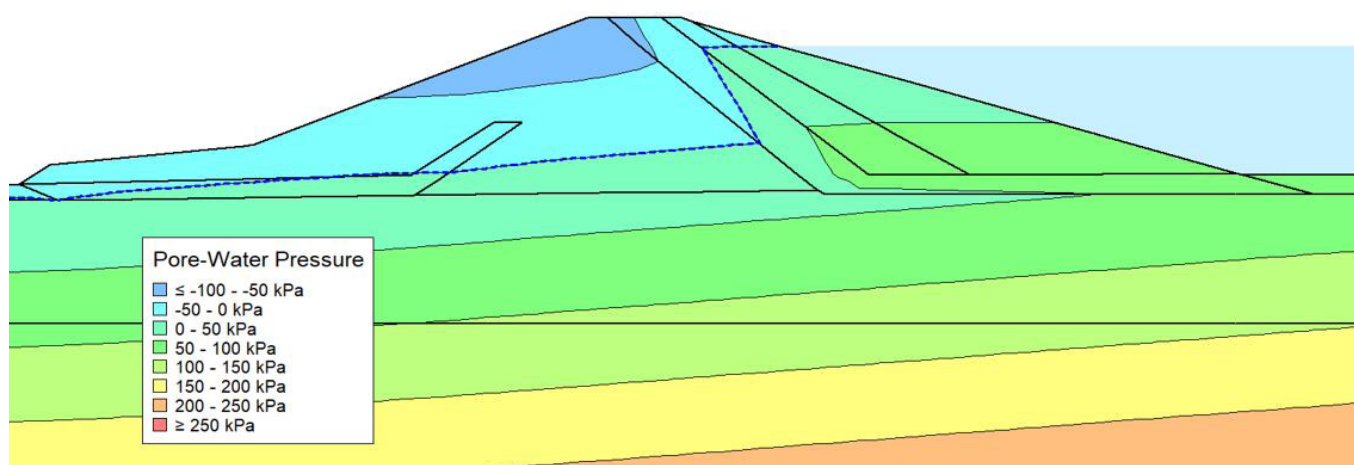
Fig. 9 Results of the seepage analysis through the dam for the calibrated and verified numerical model – plot of pore-water pressures (PV3–PV5 profile)

Figure 9 illustrates the relationships between the groundwater levels only in borehole PV8 and the seepage values in the PV3–PV5 profile for the different cut-off wall variants. The simulations indicate that the hydraulic conductivity of the wall has a stronger effect on efficiency than its thickness. In addition, the risk factors related to the filtration stability, such as the seepage rates and hydraulic gradients, were analyzed. These parameters were significantly reduced by the introduction of a cut-off wall; they reached values below the critical thresholds and thereby eliminated the risk of suffusion and internal erosion in the affected area.
