# Seepage in Existing Earthen Dams in Sri Lanka

A. I. Liyanage, N. H. Priyankara and L. S. Sooriyabandara

**Keywords:** Earthen dam, Mitigation technique, Seepage, Tissa Wewa

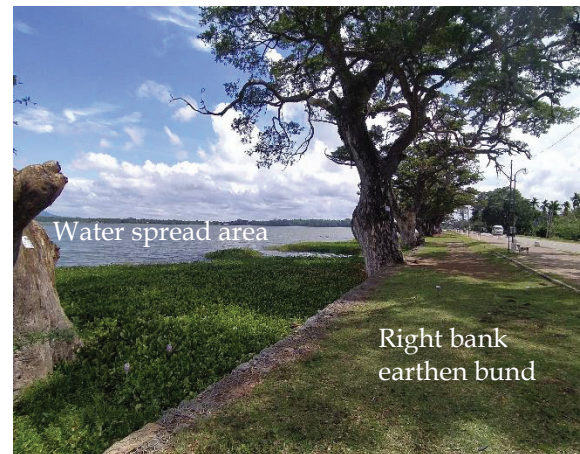
The Irrigation Department of Sri Lanka currently oversees Tissa Wewa, and Figure 3 depicts the area as it is today. Approximately 2750 acres of paddy fields are irrigated by tank water. The surface area of the tank at FSL (Full Supply Level) is 285.40 hectares and the storage capacity is 4.32 MCM (Million Cubic Meter). The tank's depth from its FSL is approximately 4.75 m. The minimum operation level is 1.53 m and the dead storage of the tank is 0.006 MCM. The type of the bund is earthen and the extended length is 1,493.52 m. The bund width is varying from 6 to 10 m and the maximum height of the bund is 4.88 m. The side slope of the bund in upstream (U/S) is 1:2 (1 vertical: 2 horizontal), whereas in downstream (D/S) it is 1:3. Tank supplies water for irrigation lands

Figure 3 - Present View of Tissa Wewa
