BULETINUL INSTITUTULUI POLITEHNIC DIN IAȘI

CONSTRUCȚII. ARHITECTURĂ

## THE EFFECTS OF ARCHITECTURAL-STRUCTURAL NON-CONFORMANCE OF THE REINFORCED CONCRETE FRAME BUILDINGS IN THE PRELIMINARY SEISMIC DESIGN STAGE (STATE OF THE ART)

**Abstract.** Reinforced Concrete (RC) Frame structures are one of the main Seismic-Resistant (SR) structural systems used by structural engineers. In these conditions, the current research study highlights the importance architectural-structural conformation of Moment-Resisting (MR) RC Frame structures in preliminary seismic design stage, so that in the current practice often results MR RC Frame buildings with increased sensitivity to earthquake. Thus, the seismic response of this structural system type required to real earthquakes was studied in parallel with seismic design specifications for RC structures, developed in P100-1 and EC 8 seismic norms. The observations regarding the effects of the inadequate architectural-structural conformation of the MR RC Frame structures overlapped with examples of real structures executed in the Iasi area (Romania). Thus, it was concluded that non-compliance with the conditions of architectural-structural conformati

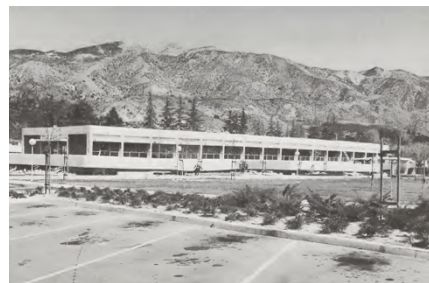
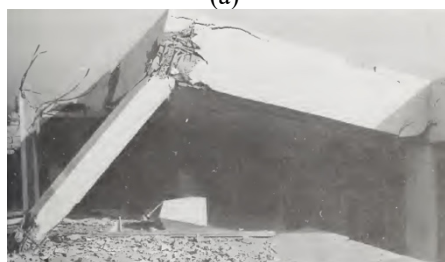
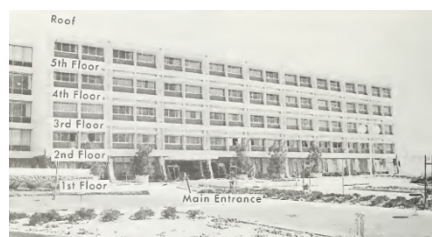
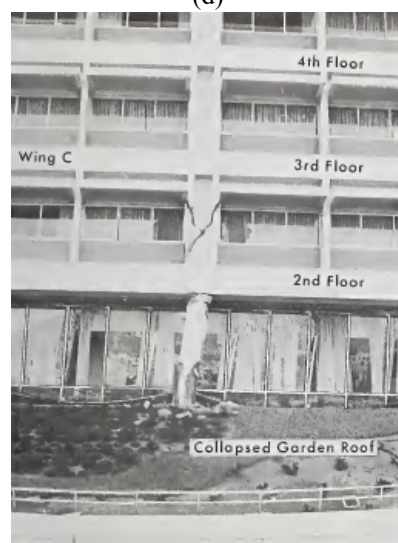
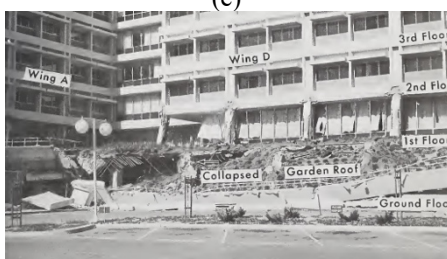
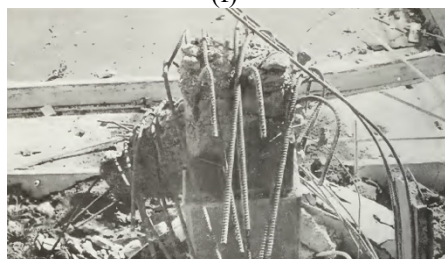
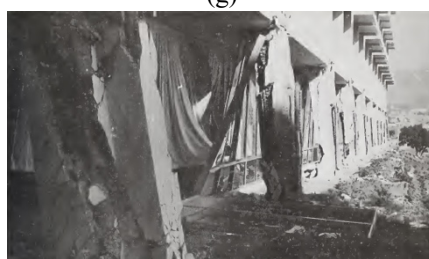
Fig. 3 – Details regarding seismic response of the Olive View Medical Center after the 1971 San Fernando Earthquake: (a) “Olive View Medical Center after the 1971 San Fernando Earthquake; (b) South and west elevations of the Psychiatric Unit (see Fig. 2 and Fig. 3 (a)). The ground story of this building was totally collapsed. What appears to be the ground floor was the first floor of this building; (c) Damage to the canopy at the front (north) entrance to the Psychiatric Unit; (d) West face of Wing A. Note the extensive damage at the first floor and the lateral displacement of the building to the north; (e) West end of Wing B. Note the contorted column and the extent of the northward drift of the building. In the right foreground is the base of the toppled stair tower. Note that this stair tower has collapsed through the roof of the ground story; (f) South face of Wing D. Note that the bulk of major damage suffered by the building is limited to the ground, first and second floors; (g) A portion of the east face of Wing C. The collapse of the garden roof as well as the extensive damage of the first floor columns can be seen. Note the lateral displacement of the building to the north, in the first story and diagonal tension cracks in the second-story column; (h) Close-up view (looking south) of one of the failed ground-story columns which originally supported the first-floor garden roof in front of Wing D; (i) South row of first story columns, in Wing D. Note the lack of ties on the corner bars which have broken out of the columns; (j) Damaged Spiral Column; (k) Wing D after stair tower overturned” (Building Science Series 40, 1971).

In Fig. 2 and Fig. 3 the seismic response of the Los Angeles Olive View Medical Center required to 1971 San Fernando Earthquake is represented in detail.

In Fig. 12 (a, b) an „H” shaped MR RC frame system is observed. The seismic response of this type of structure is represented in Fig. 3 (a), Fig. 3 (d) – Fig. 3 (i), Fig. 3 (j, k) corresponding to Los Angeles Olive View Medical Center related to 1971 San Fernando Earthquake. Also, these two structural RC frame systems have a basement on the perimeter of the building (see Fig. 12 (c)), which can lead to the rupture of the basement/ ground floor columns and the collapse of the superstructure (see Fig. 3 (a), Fig. 3 (e, f)).

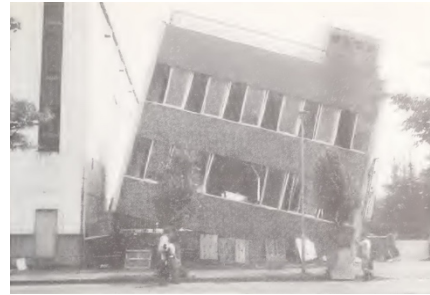
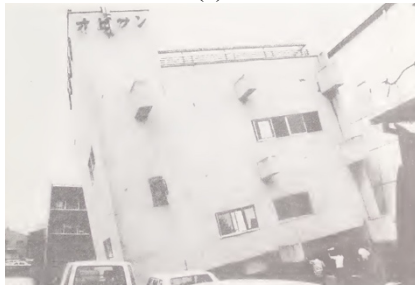
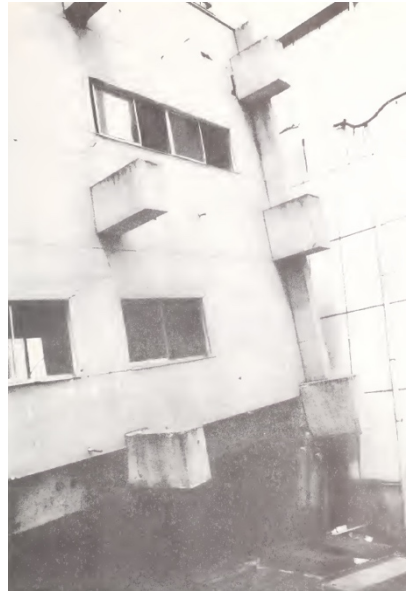
Fig. 5 – Details regarding seismic response of the Obisan Building after the 1978 Miyagi-ken-oki Earthquake: “(a) Plan details of Obisan Building, Oroshicho area; (b) Obisan Building, viewed from the North. This three story reinforced concrete frame building had a heavy eccentric stairwell cantilevered over the column line at the right end of the building; (c) Obisan Building, viewed from the south. The upper stories rotated as a rigid body when the first floor column support was lost; (d) Obisan Building, detail of southeast column; (e) Obisan Building, detail of southwest column adjacent to overhang; (f) Obisan Building, south face. Walls above first story remained essentially intact” (NBS Special Publication 592, 1980).

„This was a three-story reinforced concrete frame building with one span in each direction (Fig. 5 (a)). The portion of the building which overhung the column line by about 2 m contained a heavy stairwell. There were no

openings in the overhanging part of the building, which added to the eccentric mass. Coupled with the strong N-S motion, this caused a failure in torsion as the columns at the west end of the building were unable to withstand the forces resulting from the large eccentric mass. Fig. 5 (b) and Fig. 5 (c) show the Obisan Building after the earthquake viewed from the north and south, respectively. It may be observed that the upper stories rotated almost as a rigid body when the first floor columns failed. The first-story of the building had been used as a display area, and was completely open. A detail of the SE column is shown in Fig. 5 (d) and in the plan. As shown in Fig. 5 (e), the first floor support beams were practically resting on the ground at the west end of the building. The walls above the first-story suffered extensive cracking during the earthquake, but remained intact (Fig. 5 (f)). The reinforcing bars that can be seen are undeformed" (NBS Special Publication 592, 1980).

In these conditions, the structural system develops the first torsional vibration mode (see Fig. 11) (Ghayoumian & Emami, 2020). Practically, both the vertical regularity criteria and the structural regularity criteria in the plan (specified in the P100-1 and EC 8 seismic norms) are not respected (Khanal & Chaulagain, 2020). Also, see Obisan Building (Fig. 5) related to 1978 Miyagi-ken-oki Earthquake.

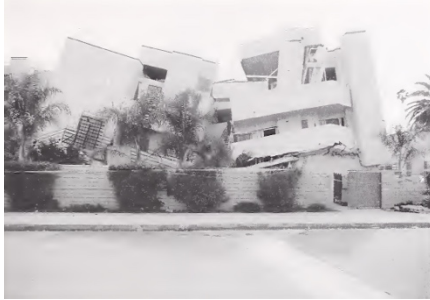
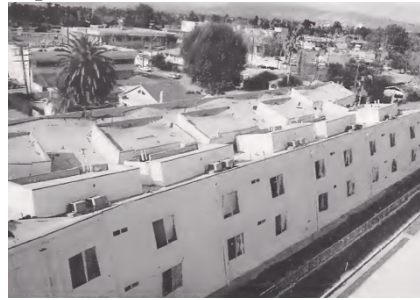
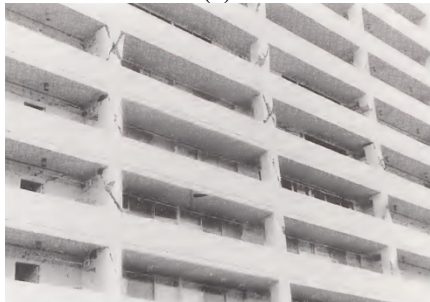
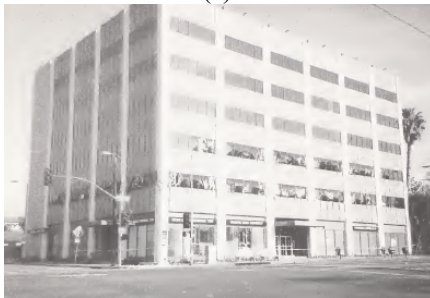
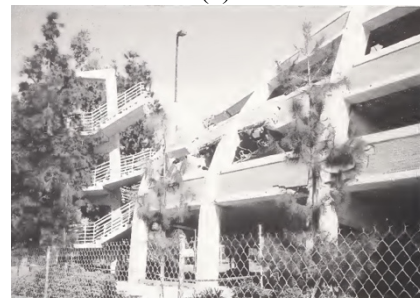
Fig. 6 – Details regarding seismic response of the few MR RC frame structures required to 1994 Northridge Earthquake: “(a) The central row of concrete first-story columns in a three story apartment building on Sherman Way in Van Nuys collapsed, causing the wood-framed upper stories to settle inward; (b) This overhead view of the partially-collapsed apartment building on Sherman Way shows the solid concrete masonry block perimeter walls along the longitudinal axis of the building. Access to the first story parking was limited to the transverse ends of the building. When the row of interior columns failed, both sides of the building settled in towards the middle; (c) The back of the Champagne Towers building was badly damaged. The railings here are solid infill, which effectively stiffen the lower half of the columns. The shortened upper half of the columns

were forced to accommodate all the displacement, and they failed in shear; (d) A closer view of the failed columns at the back of Champagne Towers shows minimal transverse reinforcement; (e) The six-story L-shaped concrete-frame Barrington Building on Olympic Boulevard in West Los Angeles lost its vertical-load carrying capacity at the second story; (f) The three-year old four-level parking garage at the Northridge campus of California State University partially collapsed in the earthquake. The collapse apparently started at the interior, causing the exterior frame to be pulled in to the middle of the structure. Precast concrete “trees” were connected to form a moment-resisting frame at the exterior of the structure; (g) The stiff infill panels of the Barrington Building effectively shortened the concrete columns, forcing all the displacement into the column sections bounded by windows. Diagonal X-cracking decreased in severity towards the top of the building; (h) The cracking in the concrete columns at the second story was so extensive that the vertical-load carrying capacity of the building was affected. The building settled 50-100 mm at the second story, as these bulging window frames attest. The worst damage was at the southeast corner, the outside corner of the L-shape, pictured here. The building, which developed a slight list, was demolished within days of the quake; (i) A close up of the damaged southeast corner of the Barrington Building shows the widely spaced, undeformed bars used for transverse reinforcement; (j) Some interior columns of the Northridge campus parking garage remained standing; (k) The cast-in-place concrete parking garage at the Kaiser Permanente Hospital complex in West Los Angeles collapsed in on itself. The moment frame that provided lateral resistance on the south face of the structure could not resist the out-of-plane forces apparently caused by the collapse of interior elements; (l) At the Northridge Fashion Center, major portions of the three-level south parking garage collapsed. The garage was precast concrete with intermittent shear walls. Most of the shear walls remained standing, largely undamaged, indicating that the lateral load was not adequately transmitted to these walls; (m) In precast parking garages, the support of the double-tees that comprise the floors is a vulnerable link in the system. This garage, at the north end of the Northridge Fashion Center, illustrates a common failure: the double-tees pulled off their supports, leaving the supporting elements essentially intact” (NIST Special Publication 862, 1994).

In Fig. 6 it is presented a few MR RC Frame structures required to 1994 Northridge Earthquake and their collapse/ rupture mechanisms.

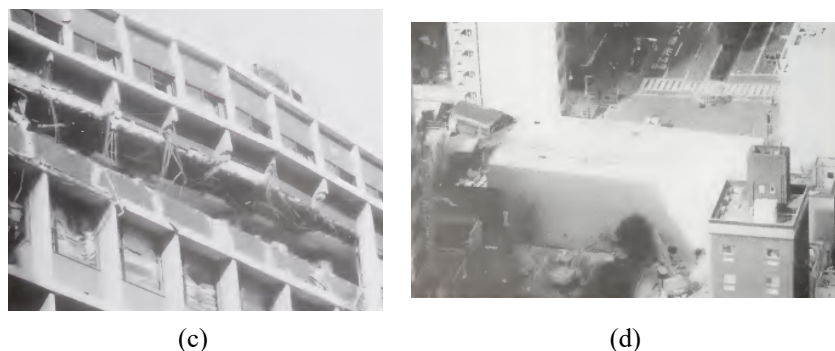
Fig. 9 – (a) “Second story collapse – commercial building in downtown Kobe; (b) Third story collapse – Downtown Kobe; (c) Upper story collapse – Downtown Kobe; (d) Totally collapsed building on Flower Road” (NIST Special Publication 901, 1996).

In Fig. 7 – Fig. 9 it is presented a few MR RC Frame structures required to 1995 Hyogoken-Nanbu (Kobe) Earthquake and their collapse/ rupture mechanisms.

In Fig. 12 (d) and Fig. 13 (c, d) shows the presence of weak first storey for MR RC frame structures for which the seismic response coincides with that for the structures represented in Fig. 7 – Fig. 9 related to Hyogoken-Nanbu (Kobe) Earthquake.

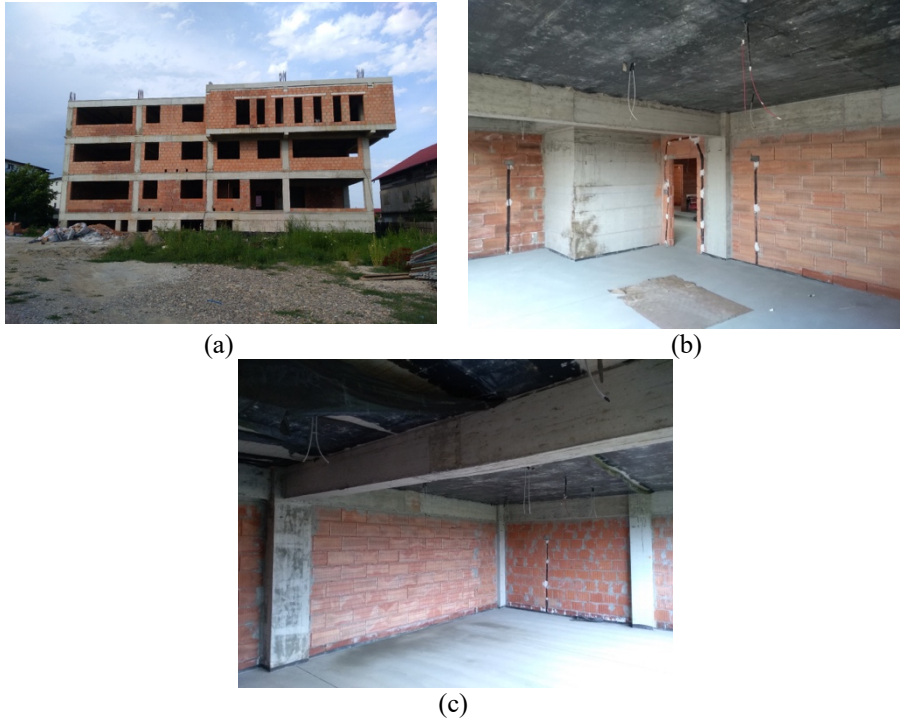
Fig. 10 – Representation of MR RC frame structure: (a) with the mass concentration of the structure at the top storey on a limited surface (Divya & Murali, 2022); (b) with rigid attachment of the elevator shaft walls to the RC frame beams; (c) with rigidly infilled masonry walls in the RC frames (Tena-Colunga A., 2021).

The structural system represented in Fig. 10 has balconies in one corner of the building, a rigid attachment of the elevator shaft walls to the reinforced concrete frame beams as well as rigidly infilled masonry walls in the RC frames.

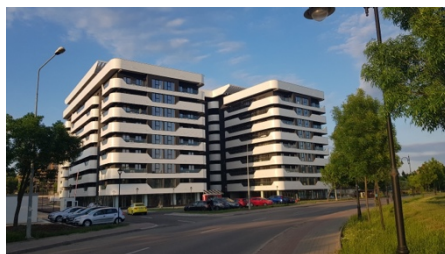
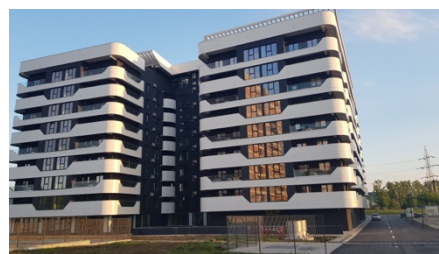
Fig. 12 – Representation of an „H”- shaped building: (a) front view; (b) back view; (c) underground parking view; (d) ground floor view – commercial space.

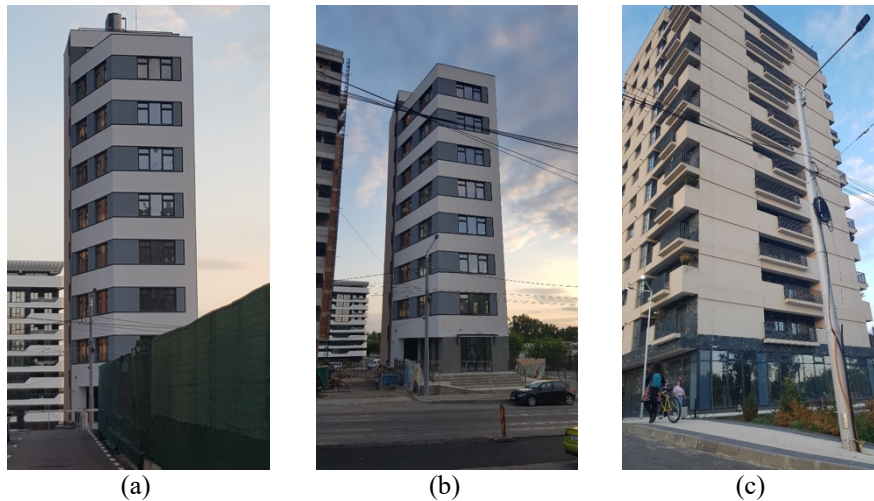
Fig. 13 – Representation of the: (a), (b) Structural system with horizontal and vertical irregularity (Archana & Abdul Akbar, 2021), (Wang *et al.*, 2018); (c), (d) Structural system with vertical stiffness difference - weak first storey and strong box created by the rest of the upper floors (Gerasimidis *et al.*, 2012).

In Fig. 13 (a, b) is a MR RC Frame system with horizontal irregularity that can dissipate seismic energy through a different mechanism than that specified in the current norms for seismic design of structures P100-1 (P100-1, 2013) and EC 8 (EC8, 2004).
