ANALYZING IMPACT BEHAVIOUR OF GLASS FIBER EPOXY COMPOSITES FOR HIGHER SAFETY SYSTEMS

Abstract: This study investigates the impact behaviour of glass fiber epoxy composites with a focus on achieving enhanced safety. A drop weight impact test machine was used to perform a series of impact tests on the composite samples. Two different impactors as dimensions and three velocities were used to investigate the impact behavior of glass fiber epoxy composites. The study's goal is to investigate the impact response of these composites and their potential for usage in impact protection applications. The study findings show that glass fiber epoxy composites have outstanding impact resistance properties, as well as high levels of the ability to absorb energy and withstand the initiation of damage. The findings suggest that both the impactor (as shape and dimensions) and the velocity of impact have a notable influence impact on the damage mechanisms and energy absorption capacity of the composite materials. The failure mechanisms detected in the composites were mostly delamination and fibre breakage.

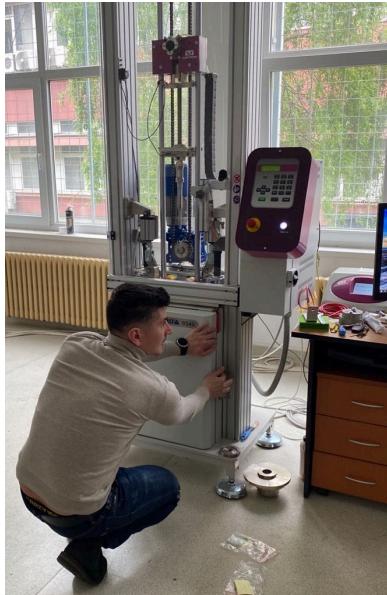
Figure 1: Instrumented drop weight impact tester (CEAST 9300 Series -Instron) during tests

The impact tests were conducted at room temperature, using Instron CEAST 9300 Series Drop tower Impact Systems, as illustrated in Figure 1. It was used to subject the composite systems to repeated (3 times) transverse impact loading conditions. Extensive research has been conducted to investigate the impact mechanism of composite materials, exploring the influence of impact energy levels, impact velocity, and impactor diameter.
