# Do Chairs Reduce a Navigator's Mobility? Pilot Study on the Influence of Navigation Bridge Design on Lookout Routines

*Despite technological progress in the maritime industry, navigators are still the final link of the decision-making chain and rely not only on equipment, but also on human senses. Visual observation of the vessel's surroundings still plays a crucial role in navigation. Four different ships in service were visited to investigate the work of professional navigators and carry out a pilot experiment on real crews to test the methods for future full-scale research. The main objective was to better understand the influence of bridge design on lookout routines of navigators, while the additional goals were to check the presence of navigators in certain parts of the bridge and to determine if it is reasonable to forbid navigators to sit, as the practice is still used on some ships. Considering space limitations and differences in layouts of the wheelhouse, rarely mentioned in this kind of study, the movement of watch-keeping officers was analysed. In total, twenty observations were made to generate the heatmaps of presence during the routine duties. The results of the r

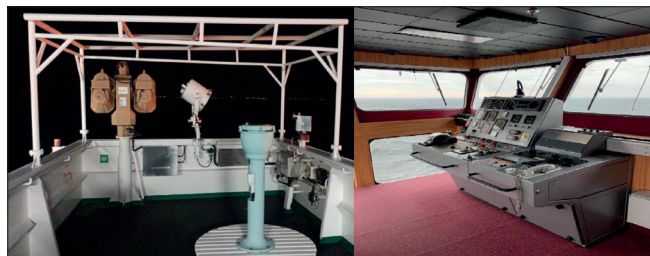
Fig. 2. Example of workstation for docking on open wing (left) and on totally enclosed wing (right)

- Workstation for docking – it should allow navigators to observe sufficient external and internal information and control manoeuvring of the ship from the wings (the parts of the bridge on both sides of the wheelhouse, which extend to the ship's side). There can be open wings or a totally enclosed bridge, where wings form an integral part of an enclosed wheelhouse [8]. Examples of workstations on open and totally enclosed wings are shown in Fig. 2;

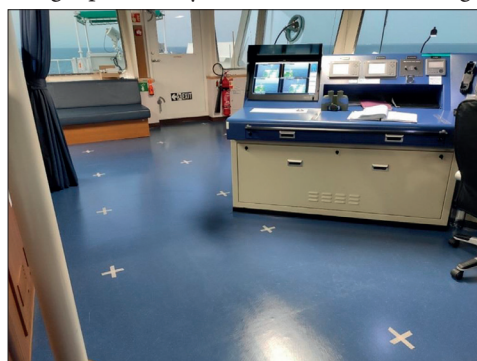
Fig. 3. Squares marked on the bridge deck with masking tape

To simplify the data collection process, the bridges were divided into squares of dimensions 1.0 x 1.0 m each and marked with masking tape for easy removal, as shown in Fig. 3.
