# Railway station in Rzeszow – social impact building, building material structure survey

Rzeszow University of Technology,  
Faculty of Civil and Environmental Engineering and Architecture,  
Department of Architecture and Cultural Heritage

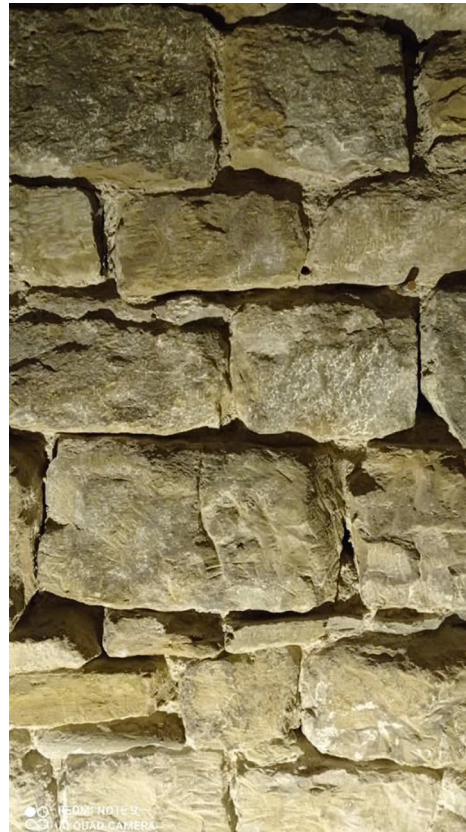
**Fig. 3.** A layered arrangement of sandstone blocks in the transverse basement wall of the Railway Station building, (photo by Krystian Sikorski)

With the architectural aspect in mind, attention was paid to the stages of construction of the building that was the object of the study, which made it possible to indicate that the material was likely taken at one time. As noted, sandstone is one of the stones commonly found in historic buildings (Domasłowski, 1975; Domasłowski, 1993; Jarmontowicz, 1998; Jarmontowicz, Krzywobłocka-Laurów, 1995; Marszałek, 1994; Bolewski, 1954).

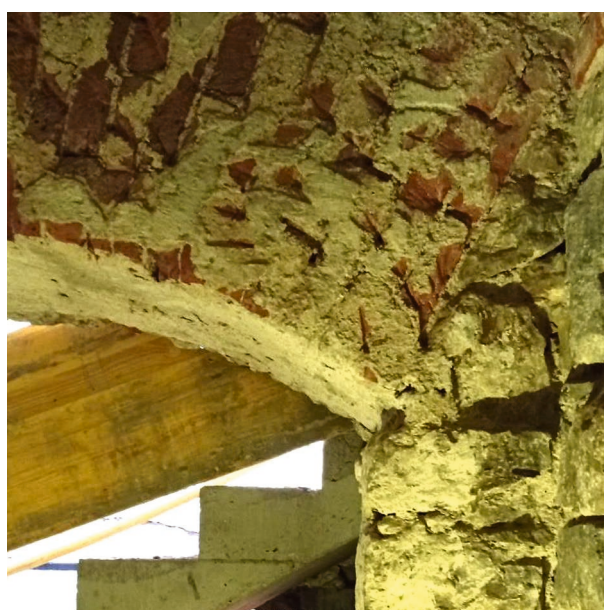
**Fig. 4.** Bonding of the stone transverse wall with a ceramic lintel (photo by Krystian Sikorski)

Significantly, the builders of the Galician Railway served their apprenticeships in the USA and western European countries, which allows the assumption of a relatively free flow of information and data on the conditions and techniques of constructing railway infrastructure (stations, tunnels, viaducts) (Preidl, 2009). This provides a rationale for concluding that, for economic and logistical reasons, the process was subject to standardisation resulting in the use of stone from local deposits. Such regularities were noted in the case of numerous tunnels belonging to the Transversal Railway, the Galician Railway and minor connecting pipes. An example is the 602 m long tunnel in Szklary, built in 1904 as part of the infrastructure of the Przeworsk – Dynów line. This structure has a casing made of locally quarried stone. Similar examples of the use of local stone deposits have been recorded in other areas of former Galicia (Preidl, 2009; Bolewski, 1954), these include: the Austro-Hungarian railway viaduct in Kraków-Grzegórzki, built between 1861 and 1863 for the railway, which has stone pillars, or the Stone Bridge viaduct in Przemyśl, built at the end of the 19th century (the viaduct structure is clad in stone blocks) and the viaduct over the railway tracks in the course of Zana Street, which has abutments made of stone blocks (Michalski, 2015; *Railway viaduct in Kraków Grzegórzki*, 2014). When considering the material used in the construction of railway station buildings, a valuable note is contained in the entry by M. Gosztyła and B. W. Motyl, which indicates that the material for the foundations of the currently functioning Przemyśl Railway Station is mixed stone and brick, while the plinth zone of the building was made of sandstone (Motyl, Gosztyła, 2019).
